CHALK MINE STABILISATION PROJECT HIGHBARNNS, HEMEL HEMPSTEAD

Treatment Area 7: Nos. 25, 26 & 27 East Green

Report Number: 0013-UA000857-TR-01-TAR-0007

OCTOBER 2015

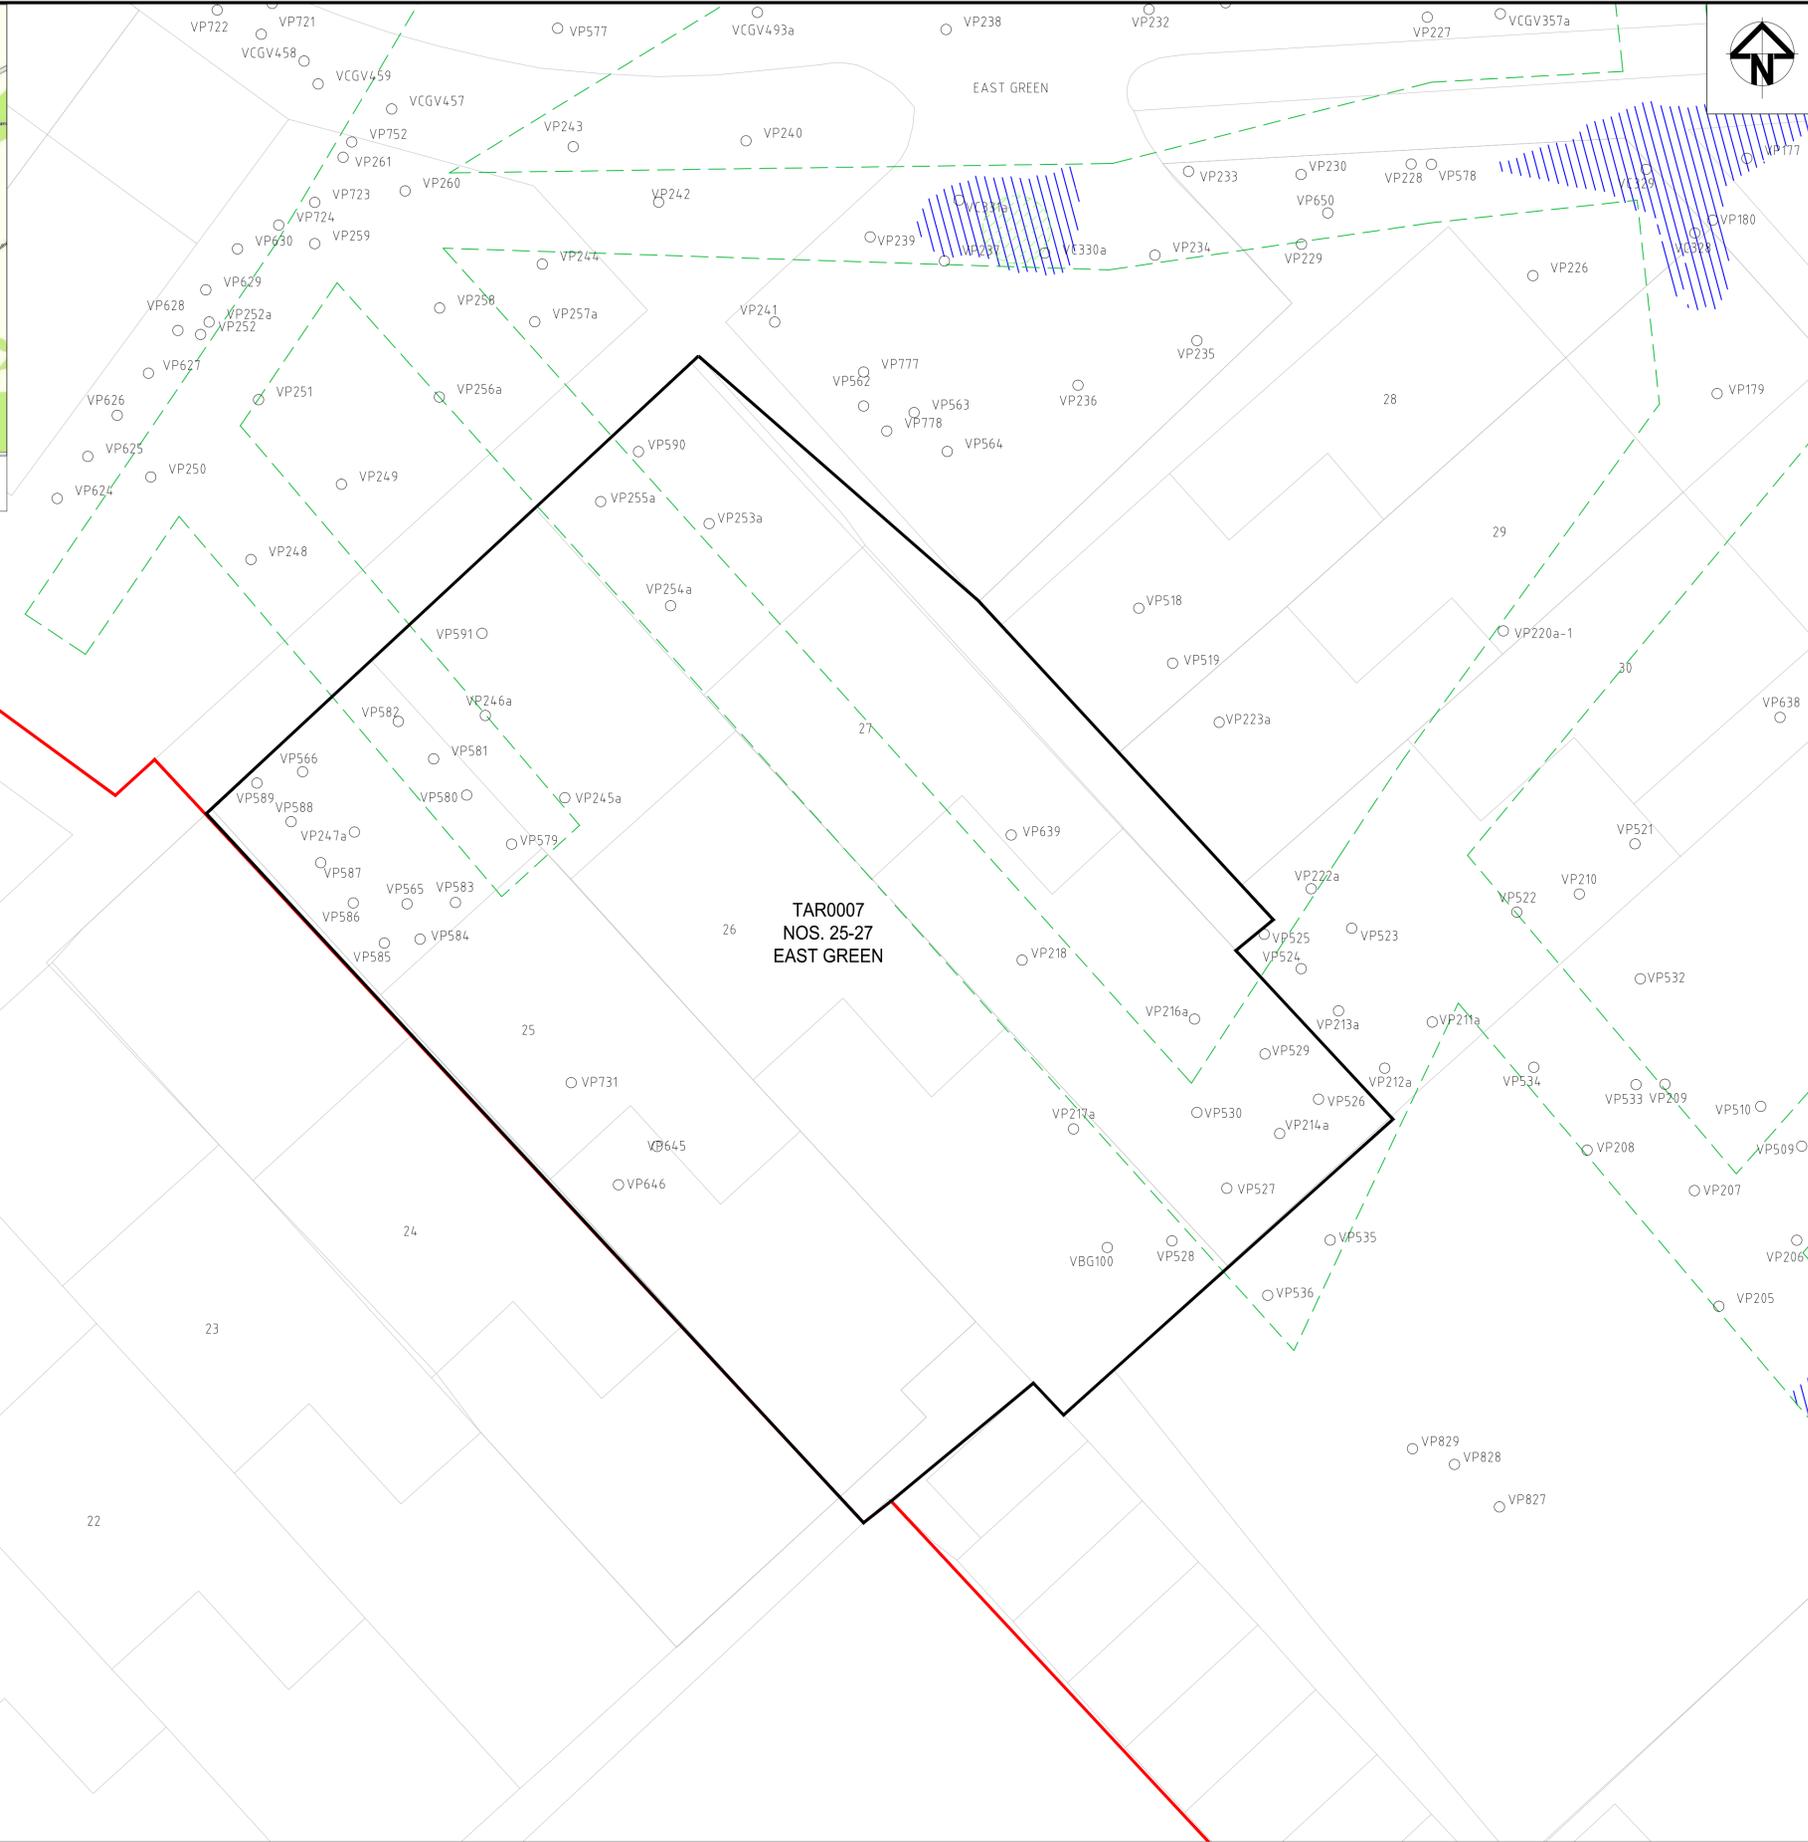
TREATMENT AREA PLAN
SCALE 1:100

Validation dynamic probing was carried out at No. 25 East Green following completion of the treatment works. A row of dynamic probes (VP583-VP589) carried out along the Derelict Land Clearance Order (DLCO) boundary did not provide evidence of further mine workings extending outside the treatment boundary. A validation probe inside the building was carried out to confirm the competency of ground conditions beneath the property following treatment while two dynamic probes carried out along the back garden aimed to confirm the termination of the assumed mine gallery. Both sets of dynamic probes did not suggest any further evidence of possible mine-related disturbed ground in the area.

A validation dynamic probe was carried out inside the dwelling out following the completion of treatment works. The results (VP639) did not suggest any further evidence of possible mine-related disturbed ground in the under the building.
