CHALK MINE STABILISATION PROJECT HIGHBARNES, HEMEL HEMPSTEAD

Treatment Area 12: 1 & 3 Pond Road

Report Number: 0013-UA000857-TR-01-TAR-0012

OCTOBER 2015

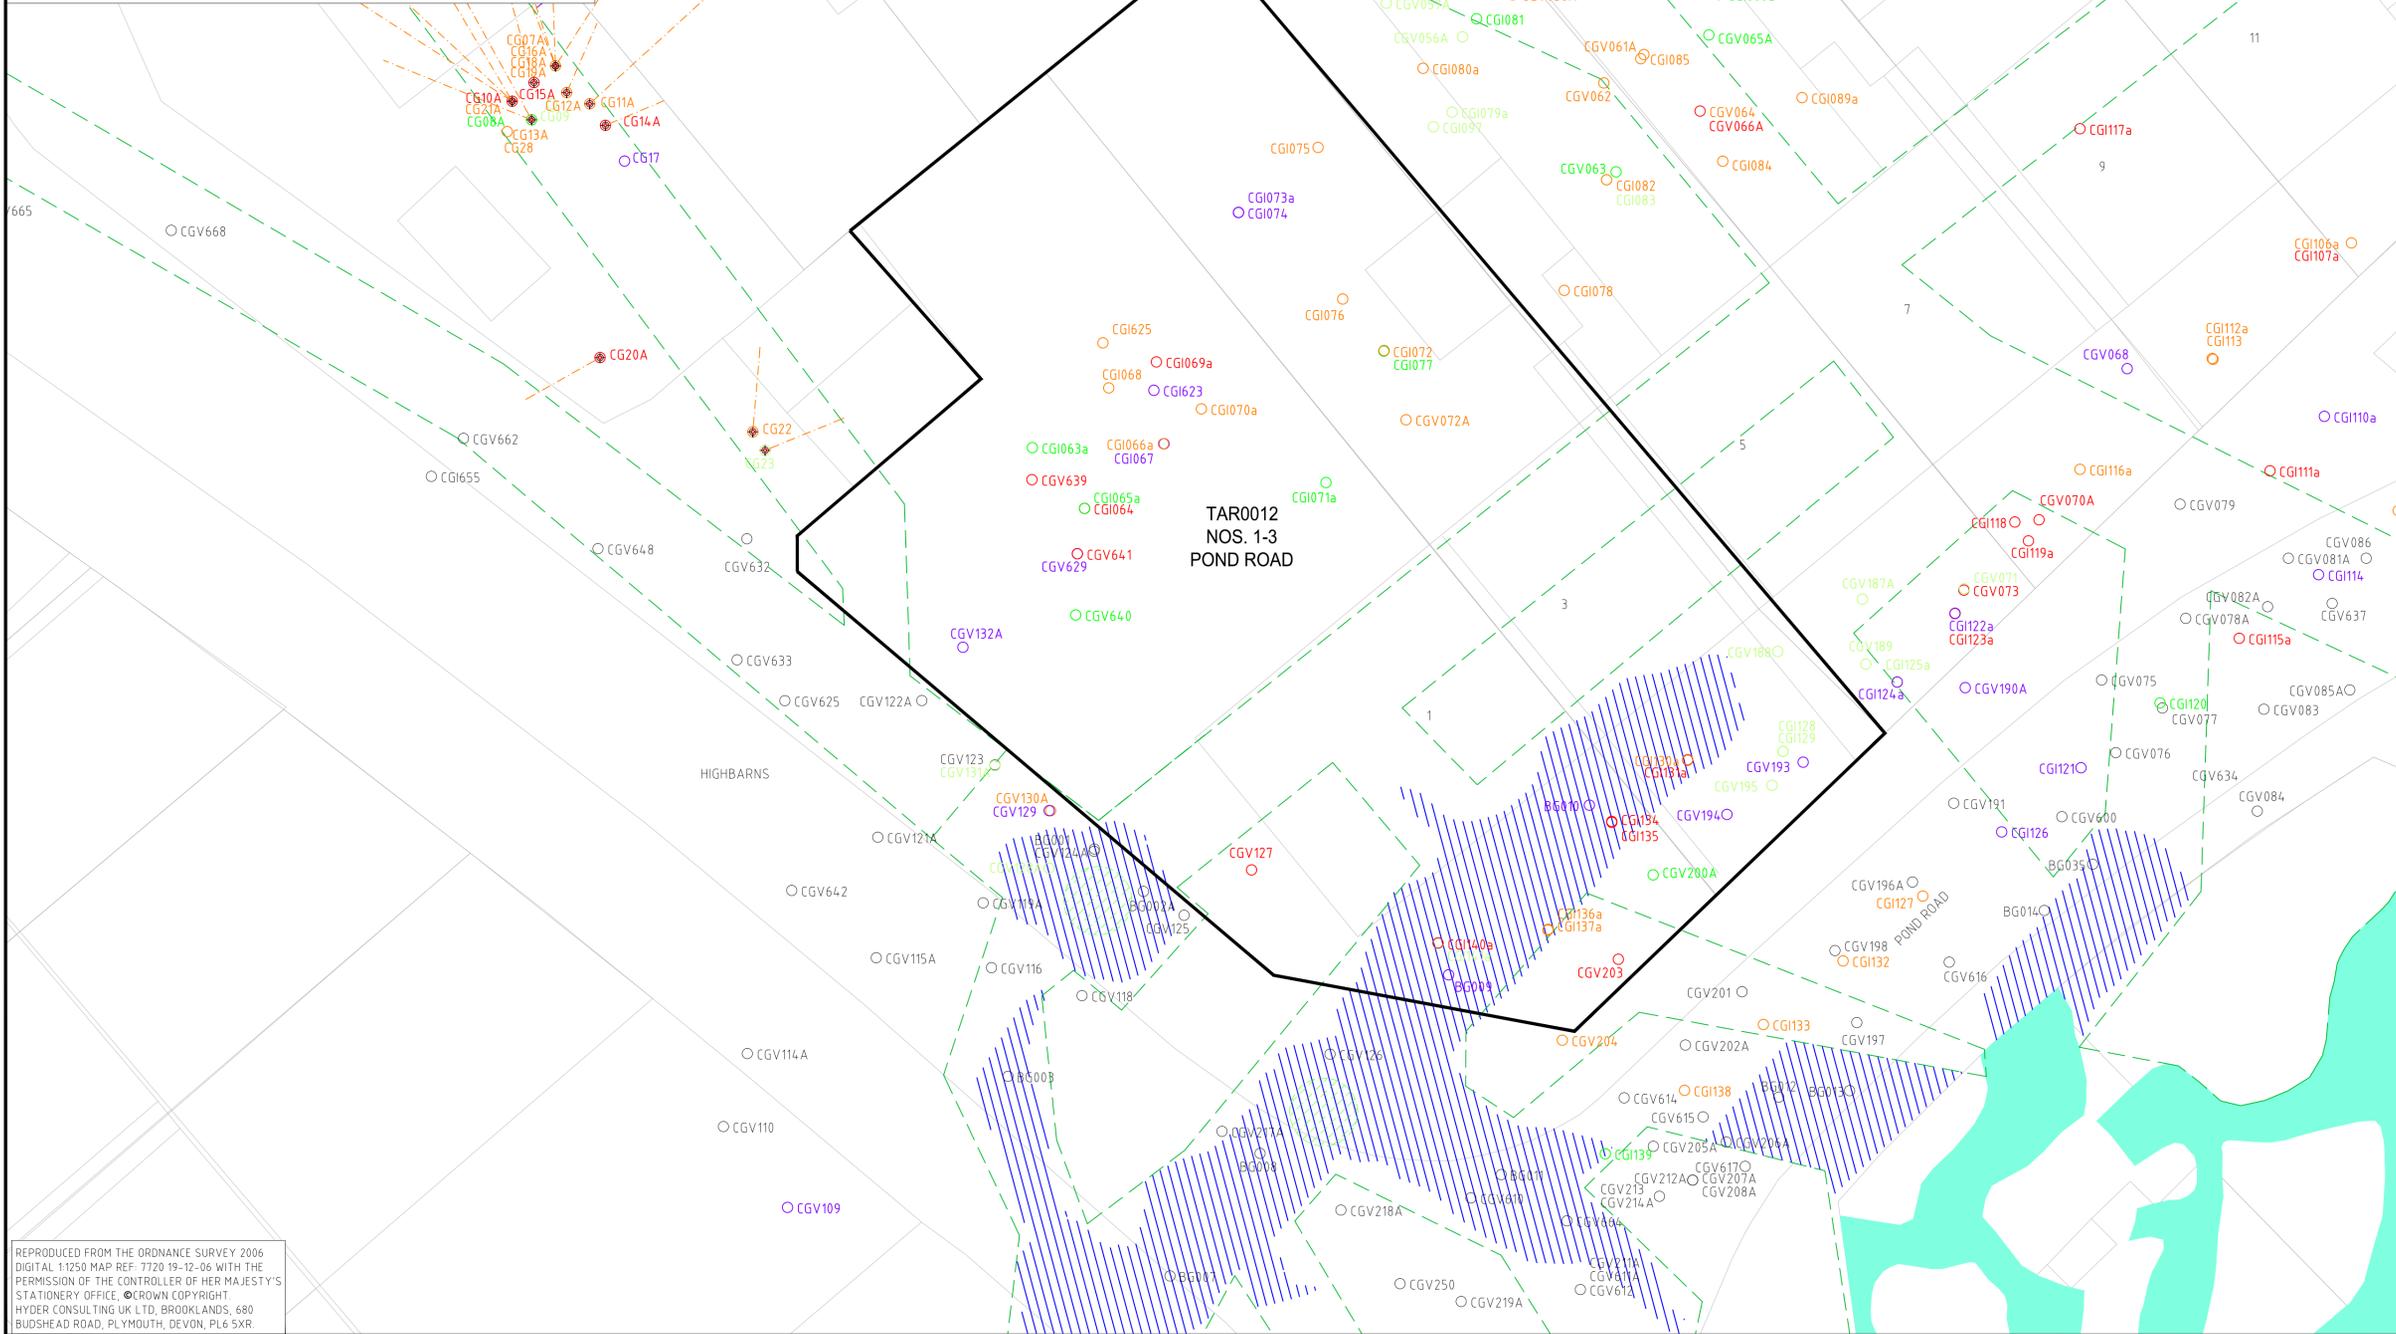
Drawing title: TREATMENT AREA PLAN FOR TAR0012 WITH GROUT HOLES

Initial treatment works involved bulk grouting aimed at infilling the known open mine workings located at the front garden of the property. The high grout volumes at two locations, BG009 (69.5m³) and BG010 (57m³), confirmed the scale of open mine workings in the area as identified during pre-treatment investigation. Further treatment was carried out along the front garden employing compaction grouting techniques to treat any further collapsed mine galleries. The grouting holes in the front gardens had relatively low grout volumes (CGV204 – 4.9m³) confirming that bulk filling had been effective in treating the open voids.

Inclined compaction grouting beneath the property was subsequently carried out and aimed from the back and front gardens. The resultant grout volumes were generally considered as average results, typical of generally collapsed ground conditions. The highest grout volume was in grout hole CGI067 drilled from the back garden (24.3m³). This was the first inclined grout hole location aimed beneath the property and this has most likely filled the residual open mine workings extending beneath the property. Subsequently inclined holes under the property had significantly reduced grout volumes typically around 4m³.

Vertical compaction grout holes were also undertaken in the back garden of No. 1 Pond Road to treat an area around the known shaft in Highbarns road and connecting passages under No 1. Grout hole locations CGV129 (21.2m³) and CGV132A (25.7m³) suggested that the mine workings may extend further into the back garden of No. 1.

Grout volumes along the front garden were characterised by two high grout volumes at adjacent hole locations CGV193 (10.1m³) and CGV194 (10.4m³). The smaller grout volumes (CGV195 (0.195m³) and CGV192 (0.199m³)) at the adjacent locations suggested generally more competent ground conditions showing that the ground had been stabilised by previous treatment. In general, low grout volumes were also observed in the inclined grout holes at these locations. Higher grout volumes in two inclined grout hole locations (CGI074 – 29.3m³) at the back of the property were thought to be related to weak ground extending from the adjacent property (No. 1 Pond Road).

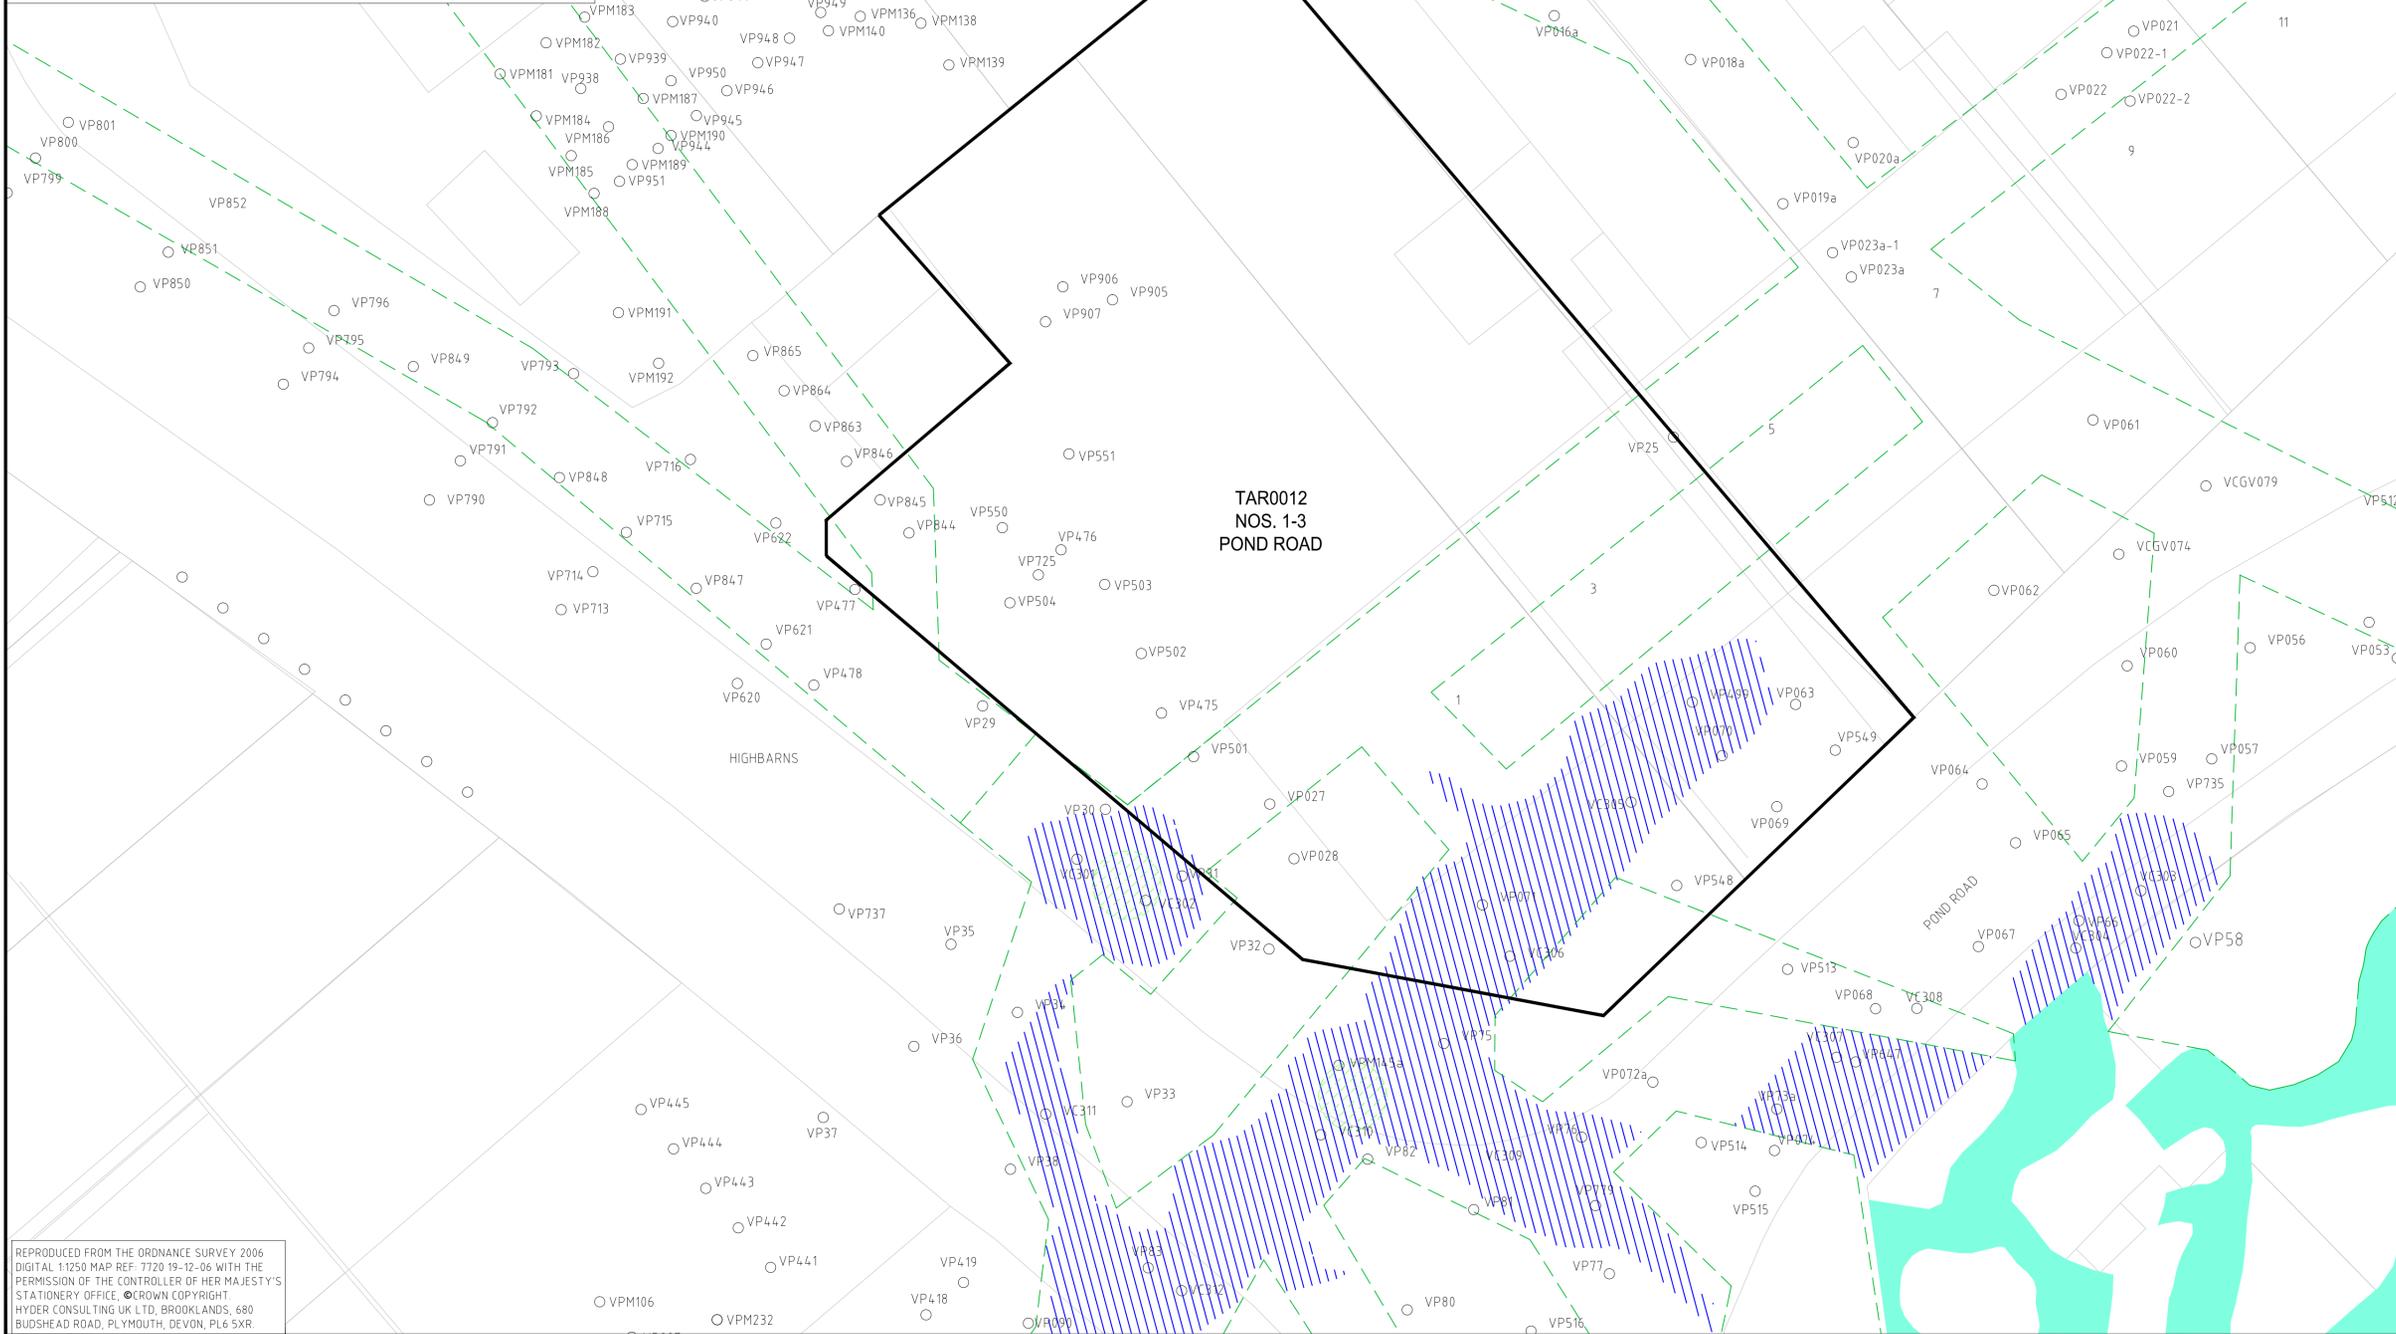
Drawing title: TREATMENT AREA PLAN FOR TAR0012 WITH VALIDATION PROBES

Following completion of scheduled treatment works as described above, validation probing was carried out at the front and side of the property. Dynamic probing in the front garden showed an improvement at the previous bulk infilling locations (VC305, VC306) as well as close to previous compaction grouting locations (VP548). Validation probing along the side of the property suggested competent treatment had been carried out. Following the high grout volumes at the back of the property (CGV129 and CGV132A), further sets of dynamic probes (VP475-478; VP501-504; VP550-551) were carried out to investigate the ground conditions to the rear of the house. Evidence of weak ground was uncovered at VP476, VP503 and VP504 in the rear garden suggestive of further mine workings. Grouting was carried in the area of this suspected mine workings with significant grout volumes recorded. The first grout hole CGV629 carried out to treat this area recorded a grout volume of 49.2m³. Subsequent grout holes recorded reduced volumes but still higher than normal (CGV639 (9.05m³) and CGV641 (9.0m³)) confirmed the need for the additional treatment, while subsequent treatment resulted in average grout volumes (CGV640

(1.09m³). Validation dynamic probing at VP725 did not identify any residual weak ground following treatment.

A validation dynamic probe, VP25, initially planned to be carried inside the property was eventually carried out in the shared alleyway due to access difficulties. Additional validation probes (particularly VP549) were carried out in areas of high grout volumes at the front of the property. The resultant probes showed did not identify any residual weak ground following treatment.
